DEPARTMENT OF TRANSPORTATION**DIVISION OF ENGINEERING SERVICES**

Contract #: 04-0120F4Cty: SF/Ala Rte: 80 PM: 13.2/13.9File #: 69.28**WELDING INSPECTION REPORT****Resident Engineer:**Pursell, Gary**Address:** 333 Burma Road**City:** Oakland, CA 94607**Report No:** WIR-015477**Date Inspected:** 06-Jul-2010**Project Name:** SAS Superstructure**OSM Arrival Time:** 1900**Prime Contractor:** American Bridge/Fluor Enterprises, a JV**OSM Departure Time:** 700**Contractor:** Zhenhua Port Machinery Company, Ltd (ZPMC), Changxing Island **Location:** Shanghai, China**CWI Name:** See below**CWI Present:** Yes No**Inspected CWI report:** Yes No N/A**Rod Oven in Use:** Yes No N/A**Electrode to specification:** Yes No N/A**Weld Procedures Followed:** Yes No N/A**Qualified Welders:** Yes No N/A**Verified Joint Fit-up:** Yes No N/A**Approved Drawings:** Yes No N/A**Approved WPS:** Yes No N/A**Delayed / Cancelled:** Yes No N/A**Bridge No:** 34-0006**Component:** Tower and OBG Components**Summary of Items Observed:**

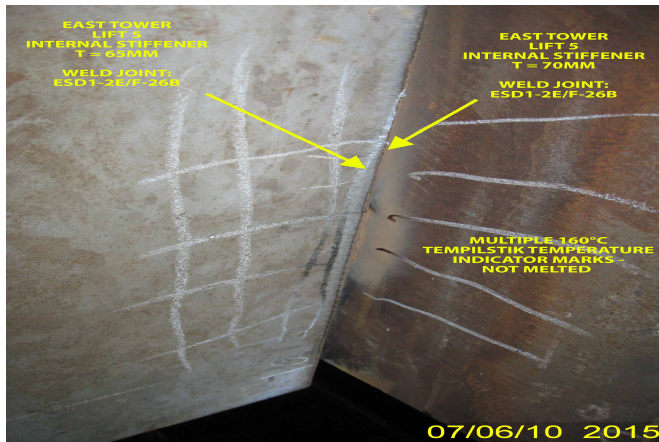
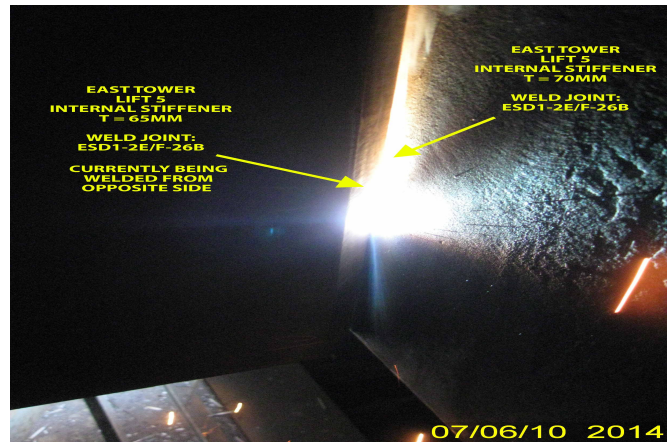
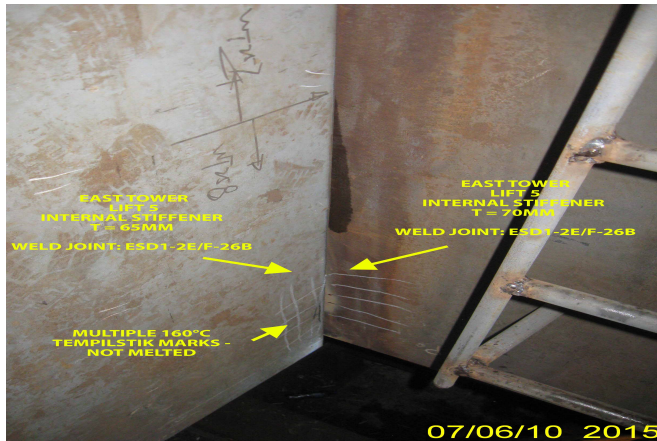
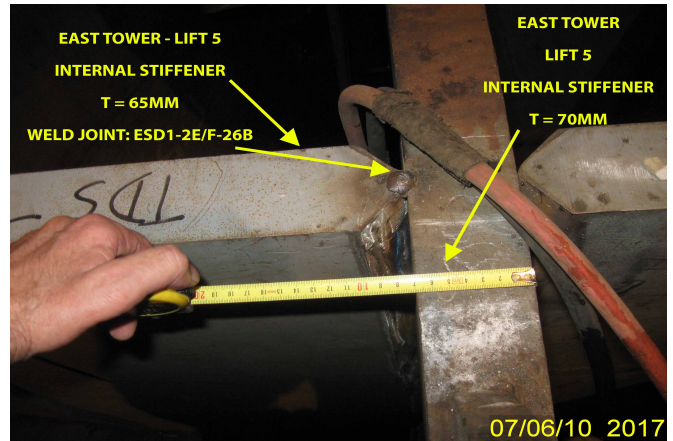
SMAW tack welding of weld joint ESD1-TL5-2E/F-26B located on PCMK east tower, lift 5, internal stiffener. Welder was identified as 202343. QC was identified as ZPMC CWI Xu Le Feng (QC1). Assisting QC1 at this location and appearing to be monitoring the welding and recording data was ZPMC QC Xu Jie (QCA1), who was not a CWI. It appeared to this QA Inspector that the welding variables were not being recorded by QC1's assistant and did not comply with WPS-B-P-3213-TC-U5b. Multiple 160°C Tempilstik temperature indicator marks applied by this QA Inspector to the adjacent base material within approximately 40mm from the point of welding did not melt. East tower, lift 5, is designated as A709M, HPS 485W-T2. WPS-B-T-3213-TC-U5b requires the minimum preheat and interpass temperature to be 160°C for material thickness more than 60mm. This QA Inspector requested QCA1 to summon QC1 to the work site. After approximately 10 minutes, ZPMC CWI Liu Yang (QC2) arrived and explained that he was assigned to welding work being performed in Bay 10. QC2 also informed this QA Inspector that QC1 was not available. This QA Inspector informed QC2, QCA1, and ABF Representative Cui Zhenghua that this QA Inspector would generate an Incident Report concerning the issue of insufficient preheat temperature. After approximately 45 minutes at the work site, when this QA Inspector departed, QC1 had not come to the work site in Bay 11. See the photos below for additional information.
